Job #	Priority	Infrastructure Jobs that require volunteers to fix		Owner	Job Started (Y/N)			
Ctrl + Click to open	1=Hi 5=Low	Brief Description of Job	Location			Volunteers/Helpers (please enter your name)	Comments	Date Completed
<a href="#">1</a>		Persistent leak from shower tray + other jobs	Room 1 - En-suite		done		Dave C investigating	18/02/2025
<a href="#">2</a>		Windblown gravel needs to clean out of gutters	Gutters (accommodation block)		done	Butch & team		20/03/2025
<a href="#">3</a>		Hallway & Fire door window surround requires attention	Accom Corridor		done	Martin Sloan		23/02/2025
<a href="#">4</a>		Clad doors to cover holes. Door bottoms poor condition.	Glider Store Double Door Repair		done			01/11/2024
<a href="#">5</a>		Kitchen gutter end stop leaking. Water running down wall.	Kitchen Gutter - West face	Ian Reily	done			17/02/2025
<a href="#">6</a>		Window is not fitting frame and does not open/close easily.	Room 8 & 9 Window Frames	Andrew Sherrington	done			03/03/2025

Infrastructure Defect No.	1
Location	Room 1 - En-suite
Date	Aug-24
Description	Persistent leak from shower tray + other jobs

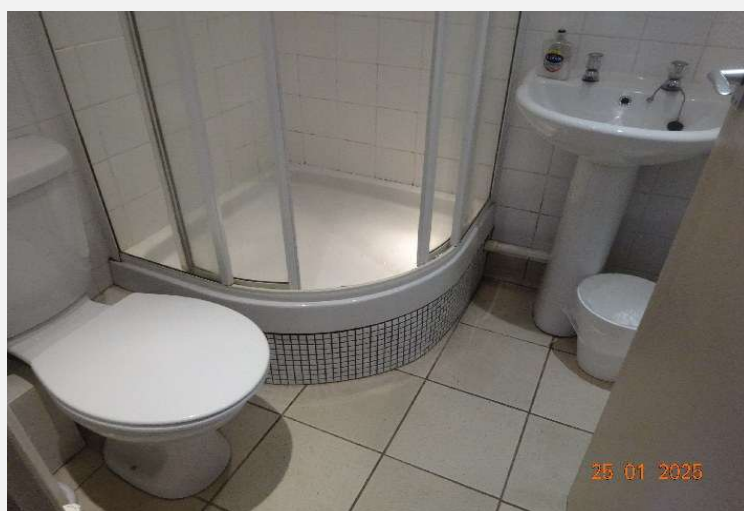
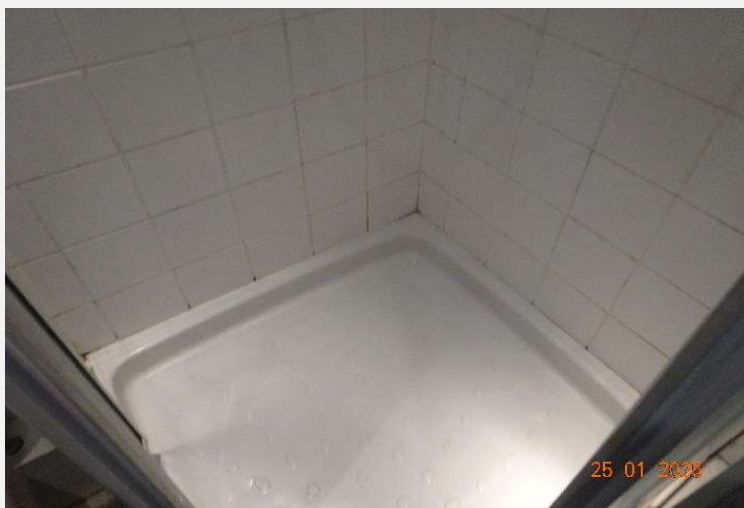
Other work required : Minor cracks in wall above skirting boards Door stop needs fitting Window surrounds need sanding down and re-painting Extractor fan is noisy and needs cleaning. If bearings gone. Replace.

The panel beneath the shower tray needs to be removed.  
The shower screen also need to be cleaned. When re-installing shower screen, be mindful of the silicone sealant. Look on YouTube to see how this is meant to be done.  
This is not a job that can be done on a single day and might require additional plumbing parts.

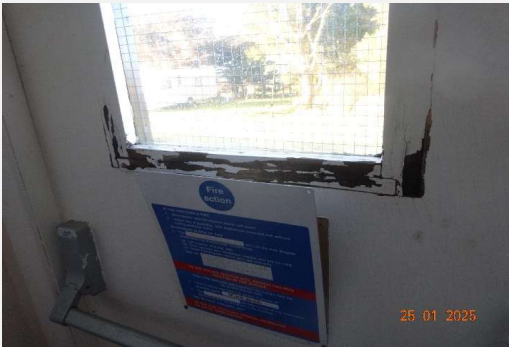
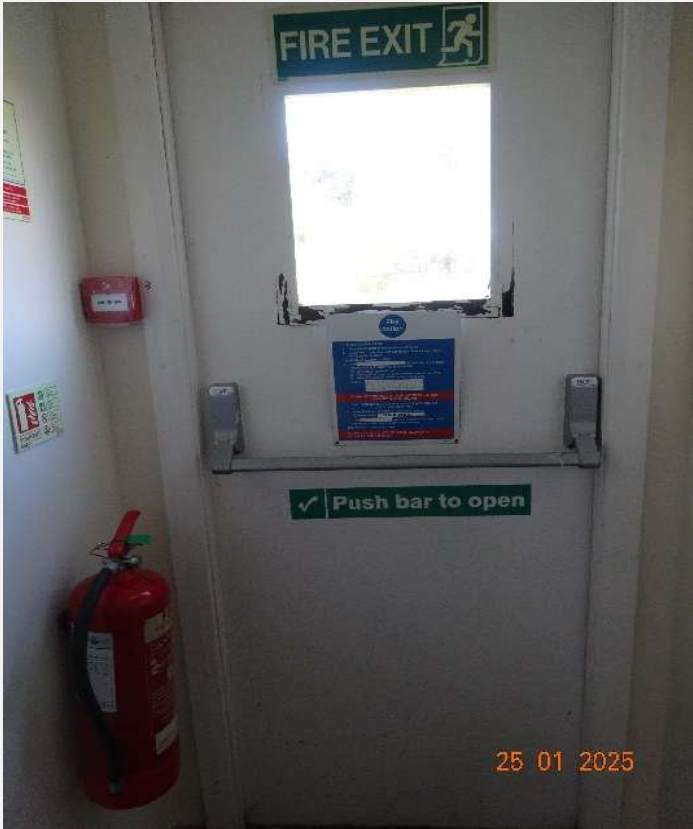
Infrastructure Defect No.	3
Location	Accom Corridor
Date	
Description	Hallway & Fire door window surround requires attention

Wood frame around window is rotten. Needs repacing and painting.  
 Some bedroom door surrounds need painting with white gloss. Presently they are in white primer. Bedroom doors need cleaning. Corridor door handle needs spring as handle is flopping down.  
 Fire door surround requires repair.

*Door 'push-plate' needs installing. 13.1m long and 1.30m Recessed door-door) is max width.*

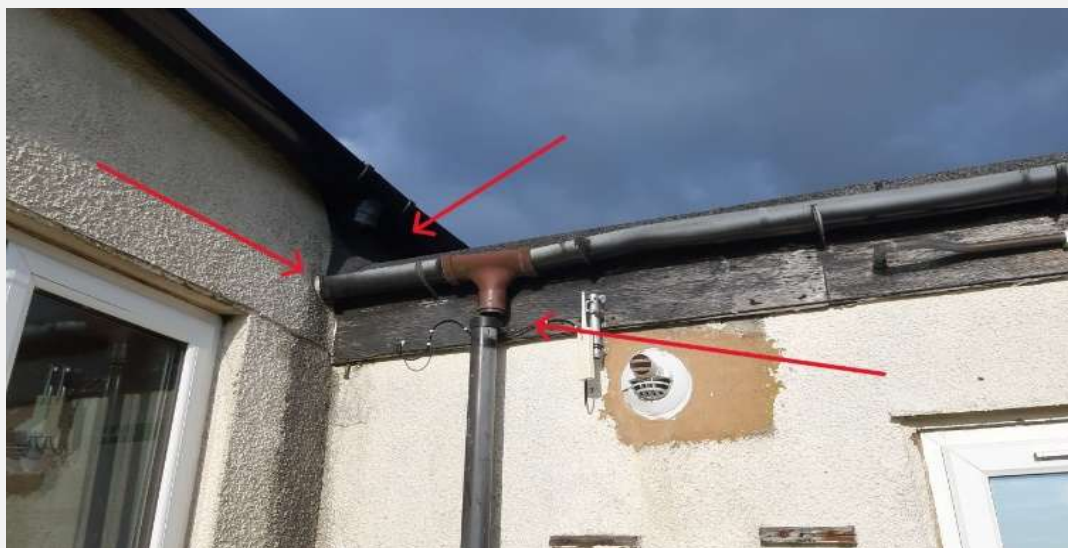
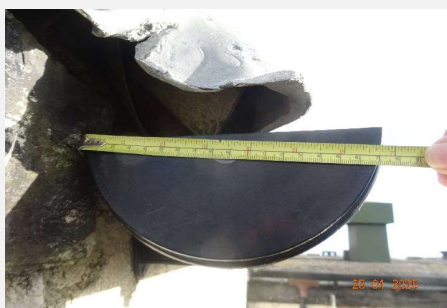
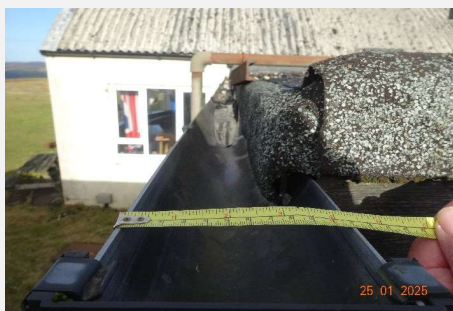
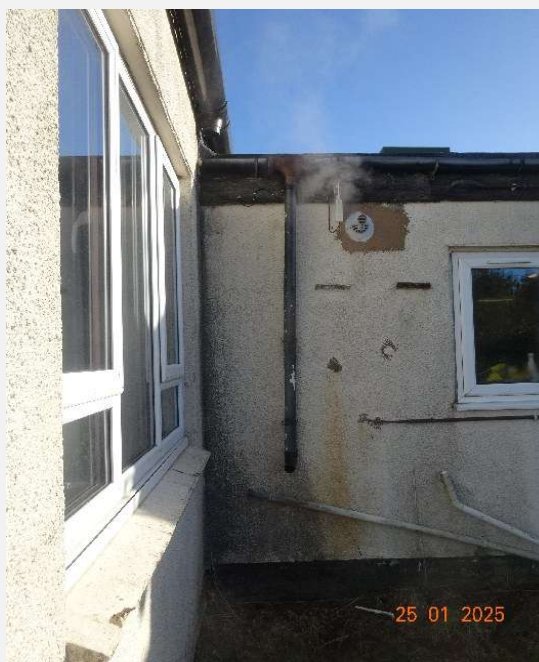
Infrastructure Defect No.	5
Location	Kitchen Gutter - West face
Date	Jan-25
Description	Kitchen gutter end stop leaking. Water running down wall.

Missing/or misaligned roof gutter parts need remedial work. The end stop is leaking badly allowing water to run down the exterior wall. New parts may be required. Step ladder work required and working on the kitchen flat roof.

N-S gutter above kitchen is 112mm half-round and down pipe 69mm diameter. E-W gutter perpendicular to that above, is 7" half-round.

There may be existing parts in the old MT shed but check with Dave Crowson they are not his.

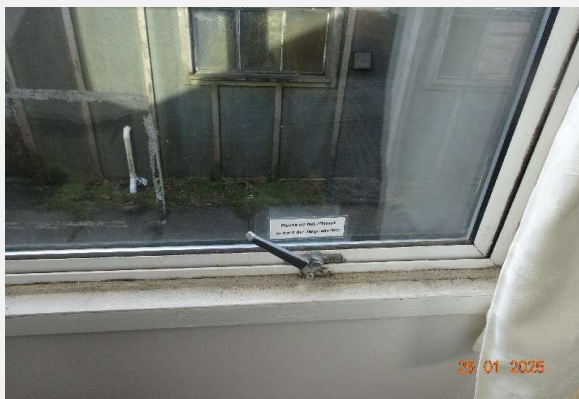
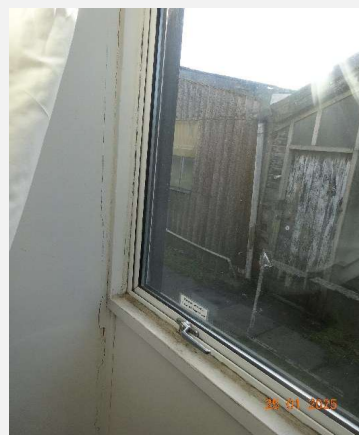
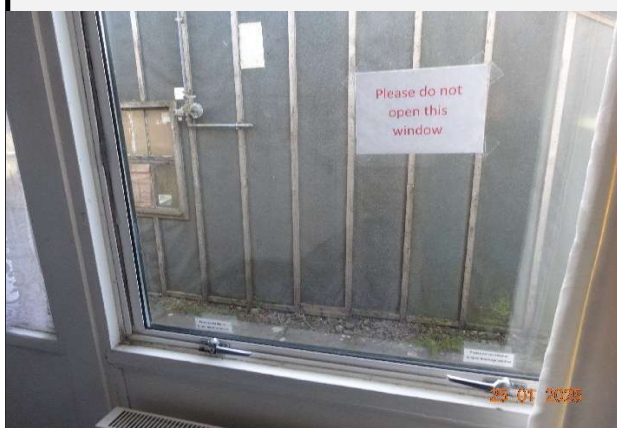
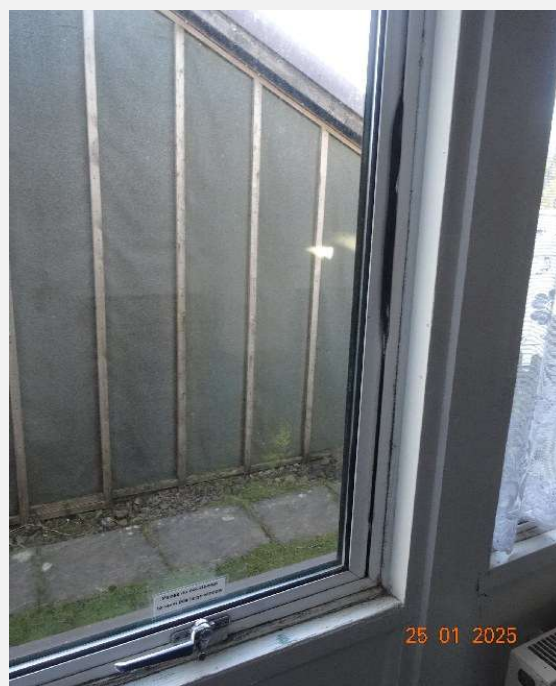
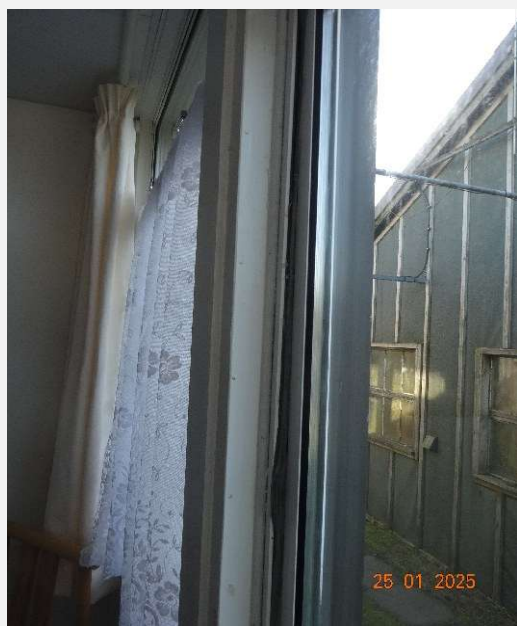
Infrastructure Defect No.	6
Location	Room 8 & 9 Window Frames
Date	
Description	Window is not fitting frame and does not open/close easily.

The window will require measurement and might involve new hinges and rubber seals. This is likely to be a two visit job as materials/spare parts are not available on site. Investigate the problem. Take measurements and next visit, do repair. Ensure plastic spacers on frame (between lock handle and frame) are in place to ensure tight closure.

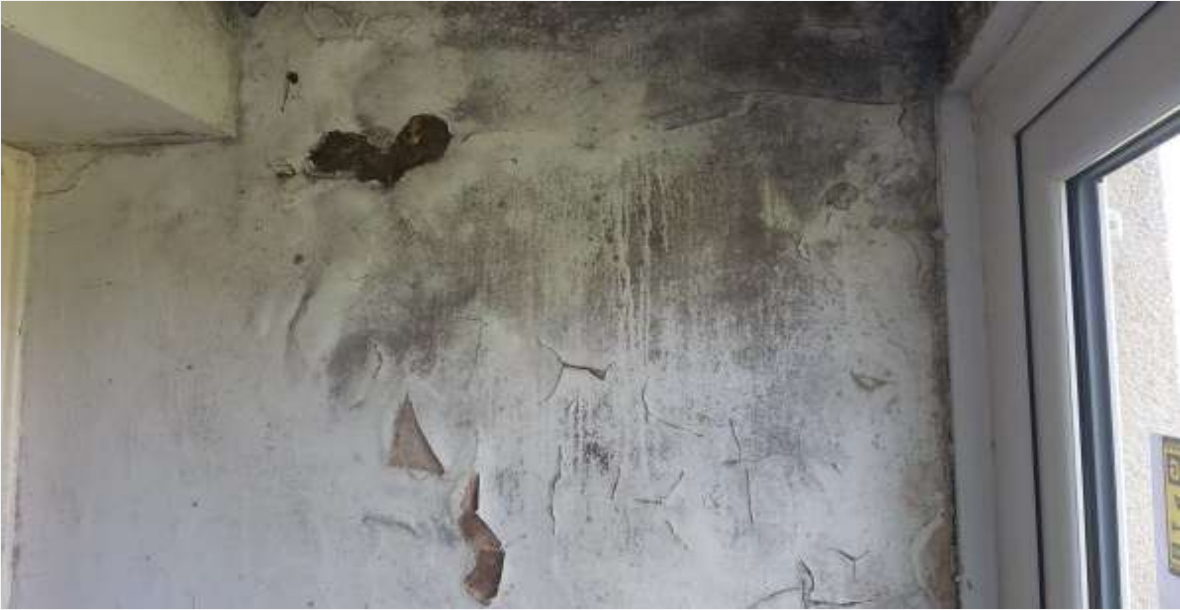
Infrastructure Defect No.	7
Location	Dining Room Lobby
Date	
Description	Inside of Lobby needs to refurbished

Due years of neglect, water has been leaking into the lobby. Refelting of the roof has been arranged which should cure the problem. Remove rotten plaster or any that is in poor condition. There is black mold on the walls so use dust masks with the outside doors open.

Any plaster removed can be used to fill the rabbit holes in front of the bay window.

Re-plastering might be the best option for this small area. This should not be a problem.

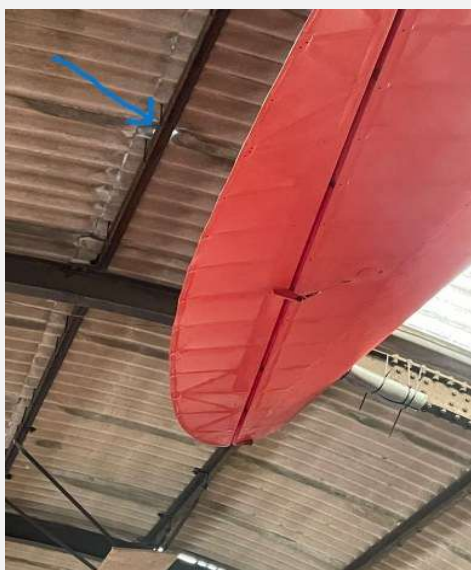
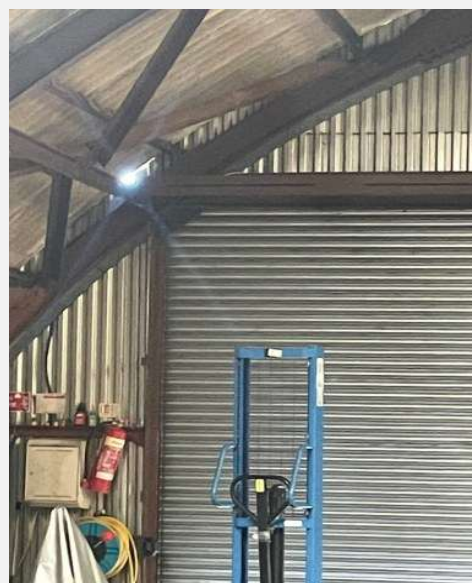
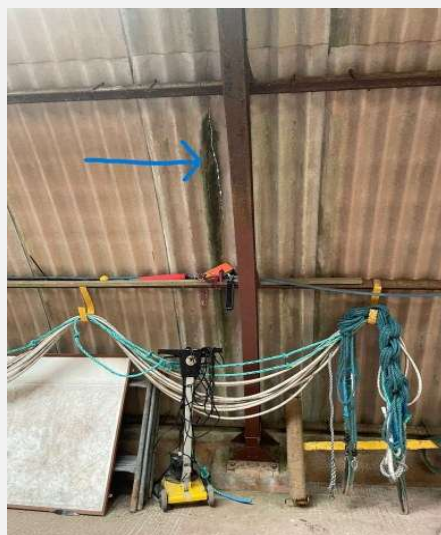
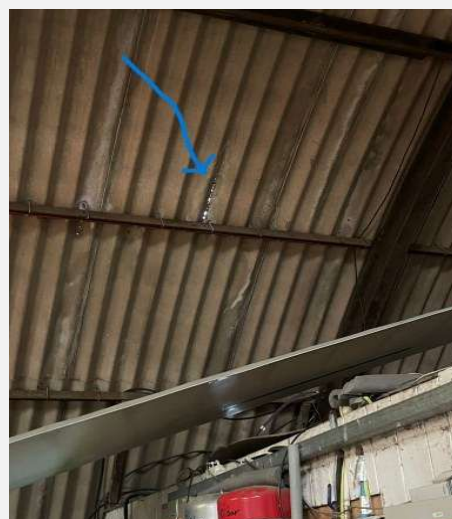
Infrastructure Defect No.	9
Location	Hangar Roof
Date	
Description	Small holes in asbestos roof require patching

There are a number of small holes in the asbestos sheet. Access from the outside is not possible due to the fragile roof, therefore. repairs will need to be done from the inside. Even access from inside is difficult due to the high roof.

Depending on the size if the hole, it may be nessassary to find a piece of sheet plastic/asbestos etc to fill the hole. Once this filler is in position, apply a piece of render mesh to cover the hole and a few inches around. Apply the liquid roof repair 'paste' (Cromopol) to the area. The Cromopol contains fibres so it should seal the gaps and make it waterproof. In the middle workshop there is a long role of render mesh. The mesh size is about 4mm. Cromopol in under the bench (north side Old MT.

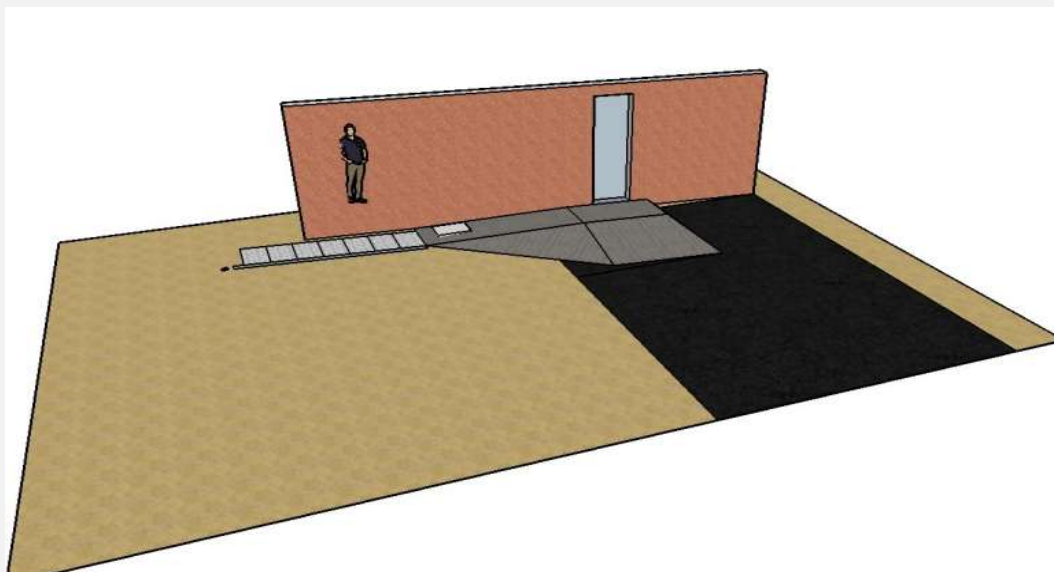
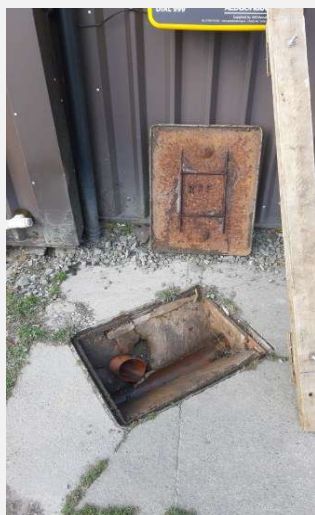
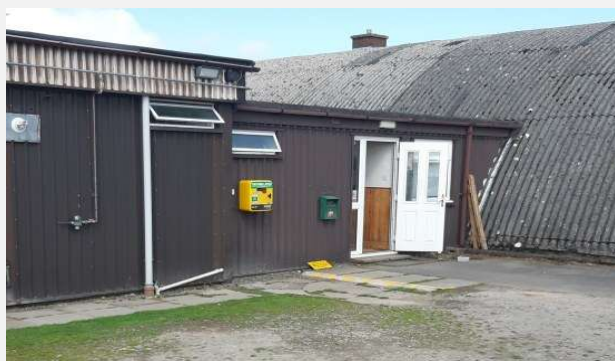
Infrastructure Defect No.	12
Location	Clubhouse Entrance
Date	
Description	Construct a Disabled Ramp into Clubhouse & Install drains

Design to follow but will involve building up ground to door level and constructing a ramp for wheelchair access. Re-lay walk-way slabs and install slotted gutter down length.

Using concrete and ballast, create a level platform at same height as doorway. Create ramp from door southwards. Using concrete raise existing ground to be at the same level as the door entry area. Raise existing manhole cover with a course of bricks. Repair inside of chamber. Relay walkway slabs & install lengths of slotted gutter on the east side of slabs. Ensure that the outlet from the gutter runs underneath the walkway to a suitable area between the accommodation and old workshops. Slotted gutter is stored in the middle workshop by ride on lawn mower.

Cut out manhole cover and raise to new ground level. Repair inside of chamber. Block pipes to prevent debris going down pipe. Isolate ladies toilet sinks.

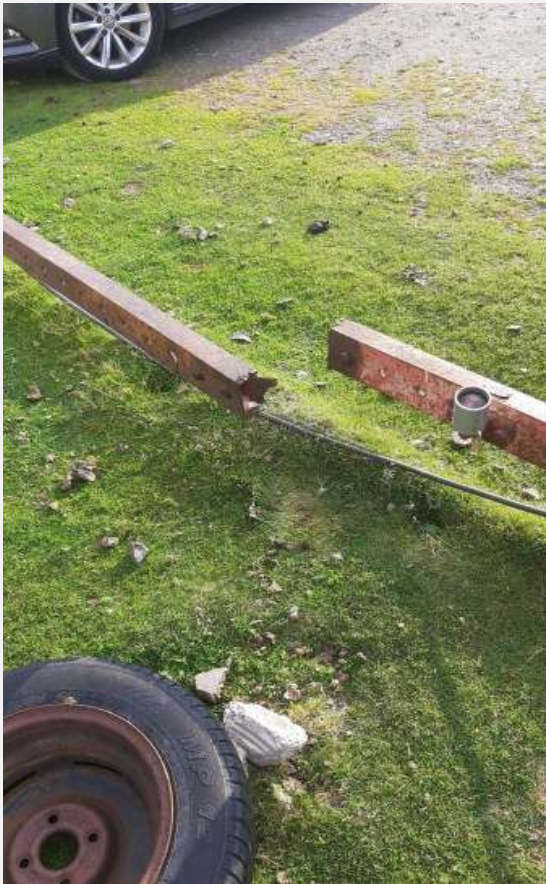
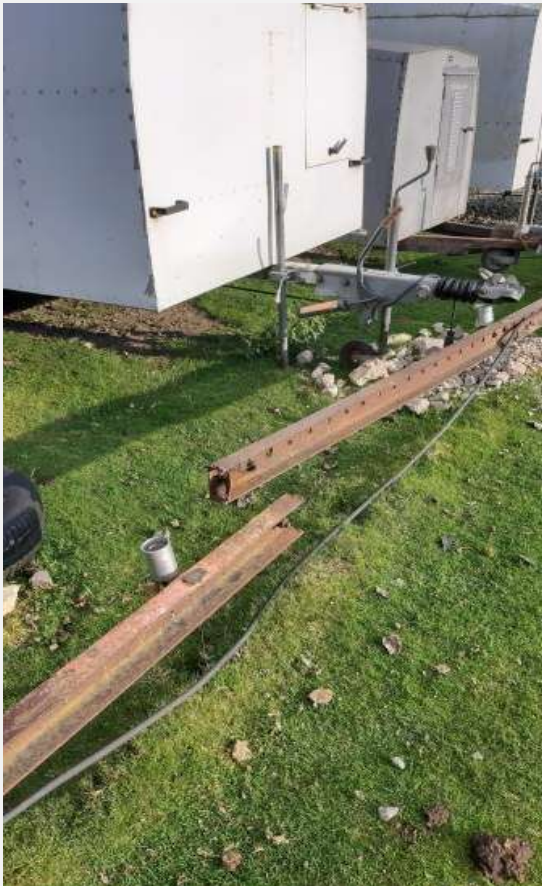
Infrastructure Defect No.	13
Location	Trailer Hitch Rail - North Side
Date	
Description	Broken Trailer Hitch Rail requires repair

Trailer rail for spaces 002-004 (nr Hangar) requires weld or splicing.  
Weld or splice with bolted plate

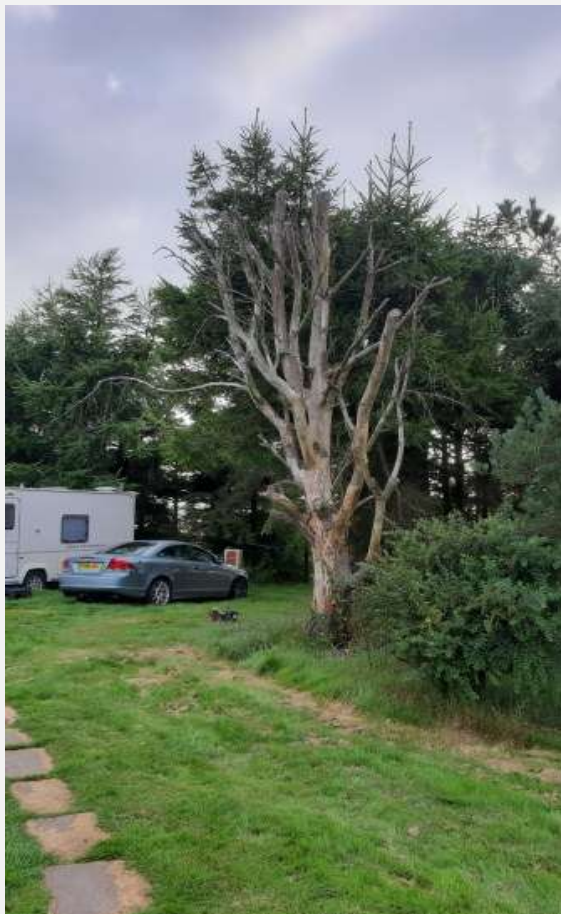
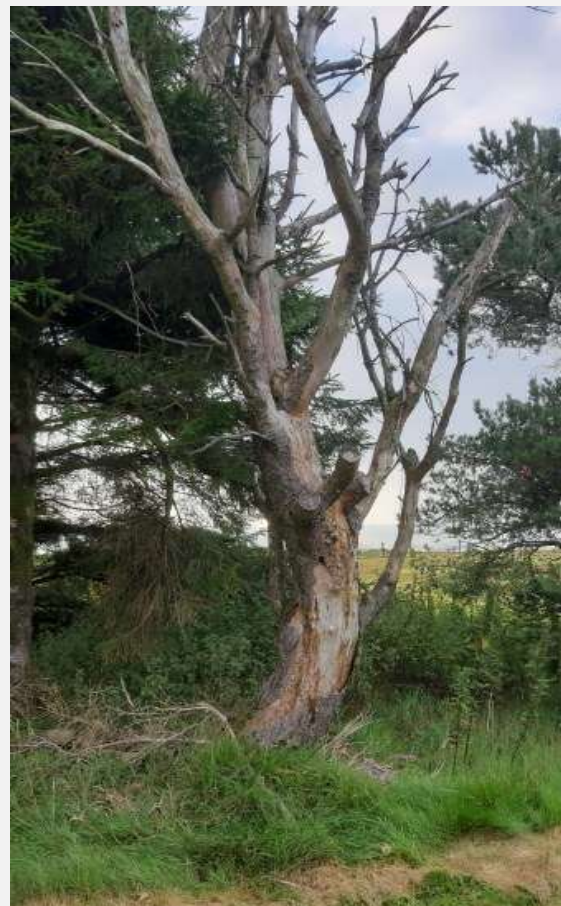
Infrastructure Defect No.	14
Location	N-Side Hangar & Caravan Park
Date	
Description	Dead Tree/ Wood Pile

Dead trees need cutting down in caravan park. Logs from fallen tree need to be dealt with. If not claimed, transport to south trailer burn area.

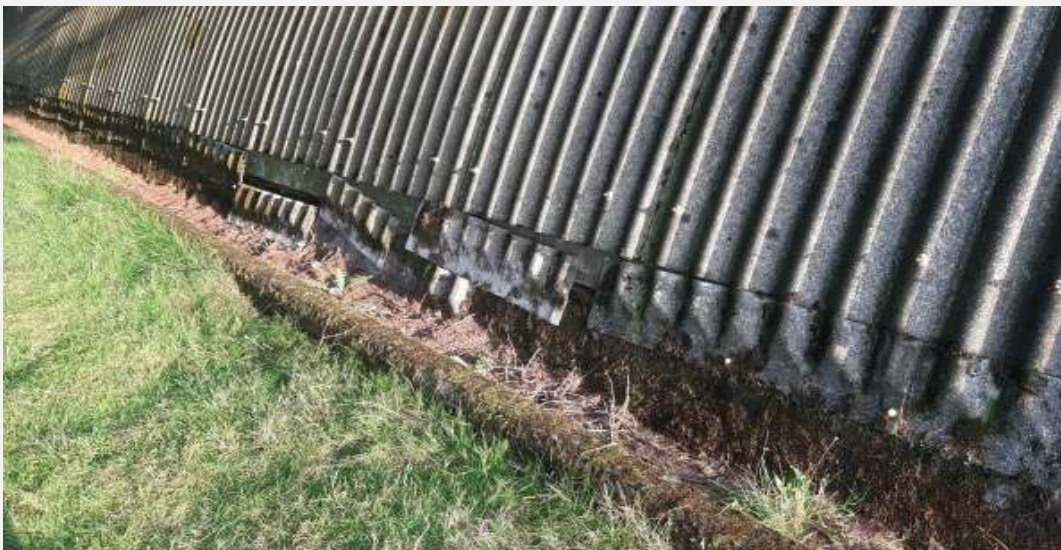
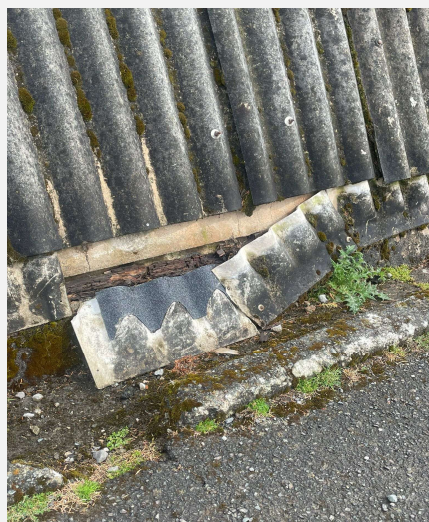
Top Photo is North Side  
Botm Photos is Walk Way South Side by Office

Infrastructure Defect No.	15
Location	North Side Hangar Lower Roof Skirt
Date	
Description	Slipped panels require reposition/fixing.

Slipped Panels. Some bottom panels on both North & South side of hangar have slipped. Needs a wooden piece attaching and the panels screwed into the wood.

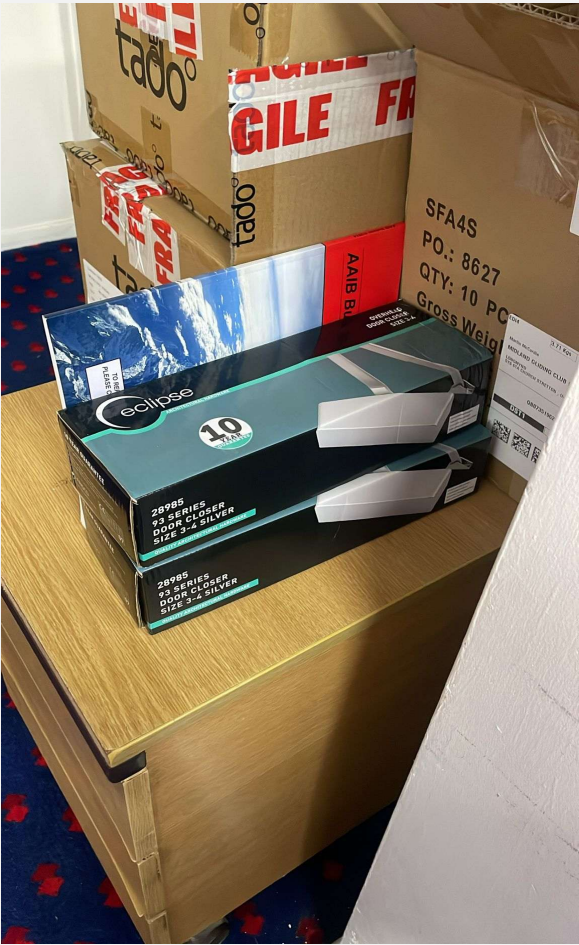
Infrastructure Defect No.	16
Location	Kitchen
Date	
Description	Door Closer need changing

Mark Wakeham has changed the ladies toilet but the unit in the kitchen needs maintenance or changing.

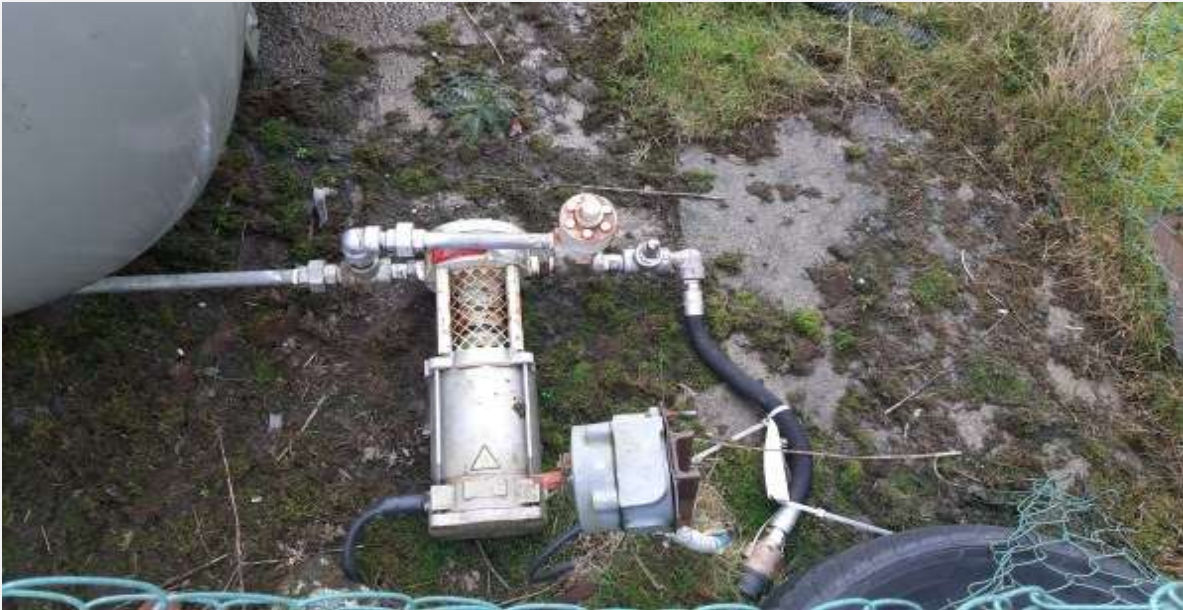
Infrastructure Defect No.	17
Location	LPG Enclosure
Date	
Description	Electric LPG & Manual LPG Pump needs protective Housing
<p>Ideally, a alumium protective cover that latches to base. Alumium sheets (from old trailer) available either in old MT Shed or at south end of trailer hitches. Existing electric switch will be replaced &amp; relocated.</p>	
Comments	
<p>A similar cover is required for the new Manual LPG Pump. This is due for install soon.</p> <p>Existing electric switch will be replaced &amp; relocated.</p>	
Photos

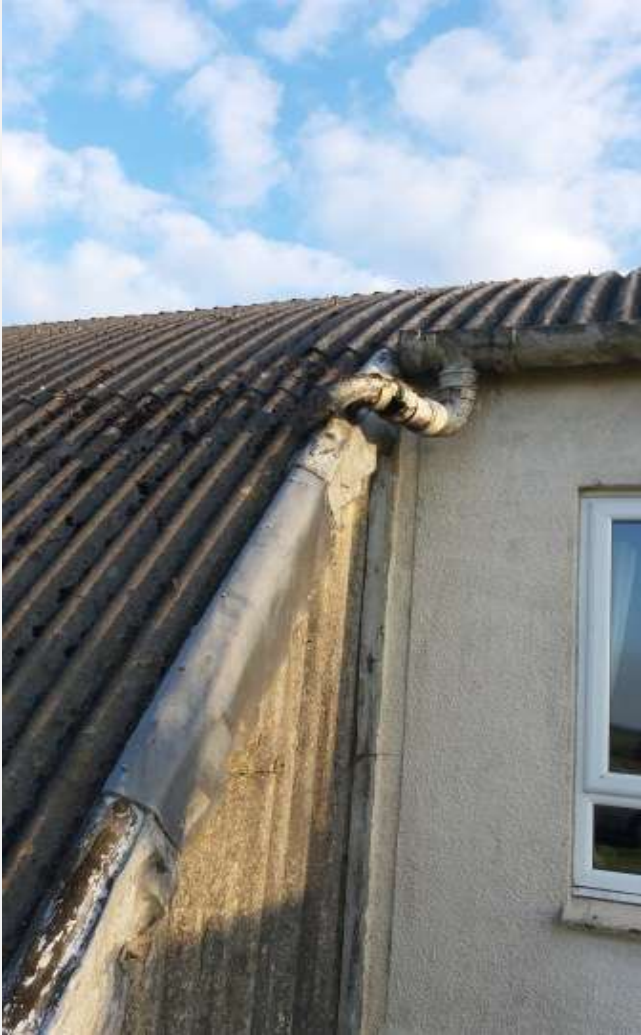
Infrastructure Defect No.	20
Location	North Hangar Gutter
Date	
Description	Running Outlet needs to be fixed

Gutter has been cleaned and repaired during last summer. The outlet is presently broken allowing water to run down side of building.

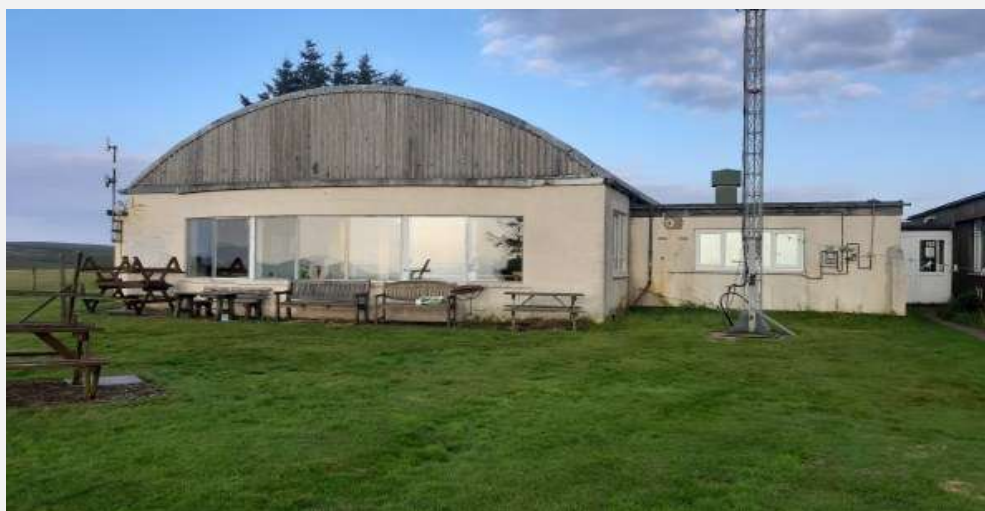
Infrastructure Defect No.	21
Location	Clubhouse Exterior Walls
Date	
Description	Prep & Re-Paint with Masonary Paint

Strim the grass and weeds that are along the base of the walls. Follow this with painting the walls. When complete and if there is the manpower, ideally, dig out the grass/turf and lay at least 30cm+ wide weed fabric. Then using wheel barrow, put down rock chippings along the base of the wall. This is a straightforward job that can be shared by several people.

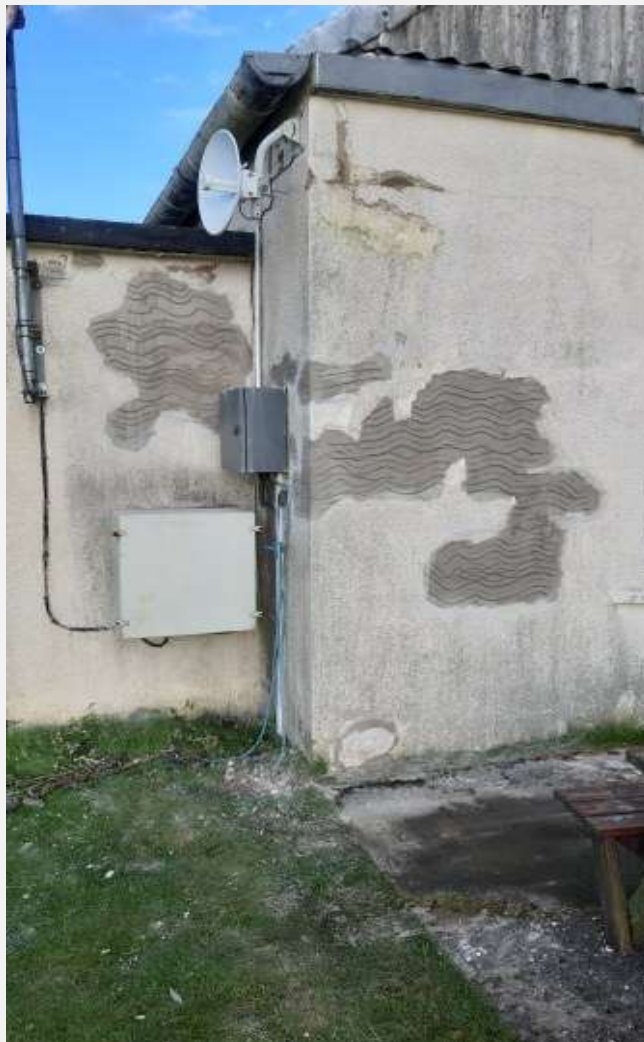
Infrastructure Defect No.	22
Location	West Face of Clubhouse
Date	
Description	Finish Rendering previous repairs

A scratch coat of render has already been applied, making good the rotten water damaged render. A top-coat is now required to be done in good weather. Repaint accordingly.

. Simon Adlard has lent his splatter gun for the job. Splatter mix is 1 cement : 4 Plaster Sand.

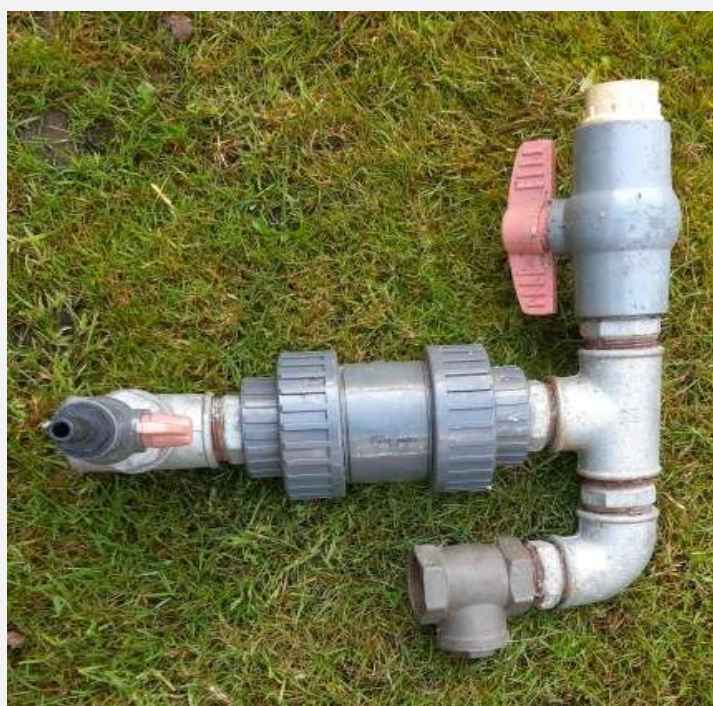
Infrastructure Defect No.	26
Location	Workshop
Date	
Description	Water Ram Pump needs to be returned to service

A donated Water RAM pump needs to be bought back to life. Essentially in good condition but needs a little bit of plumbing....and an understanding of hiw these things work.

Pump will be sited on the East Face spring to pump water to the black water tanks and also to water store.
