# Safety Information Bulletin Airworthiness

SIB No.: 2019-07

Issued: 30 April 2019

Sailplane Rigging – Procedures, Inspections and Training

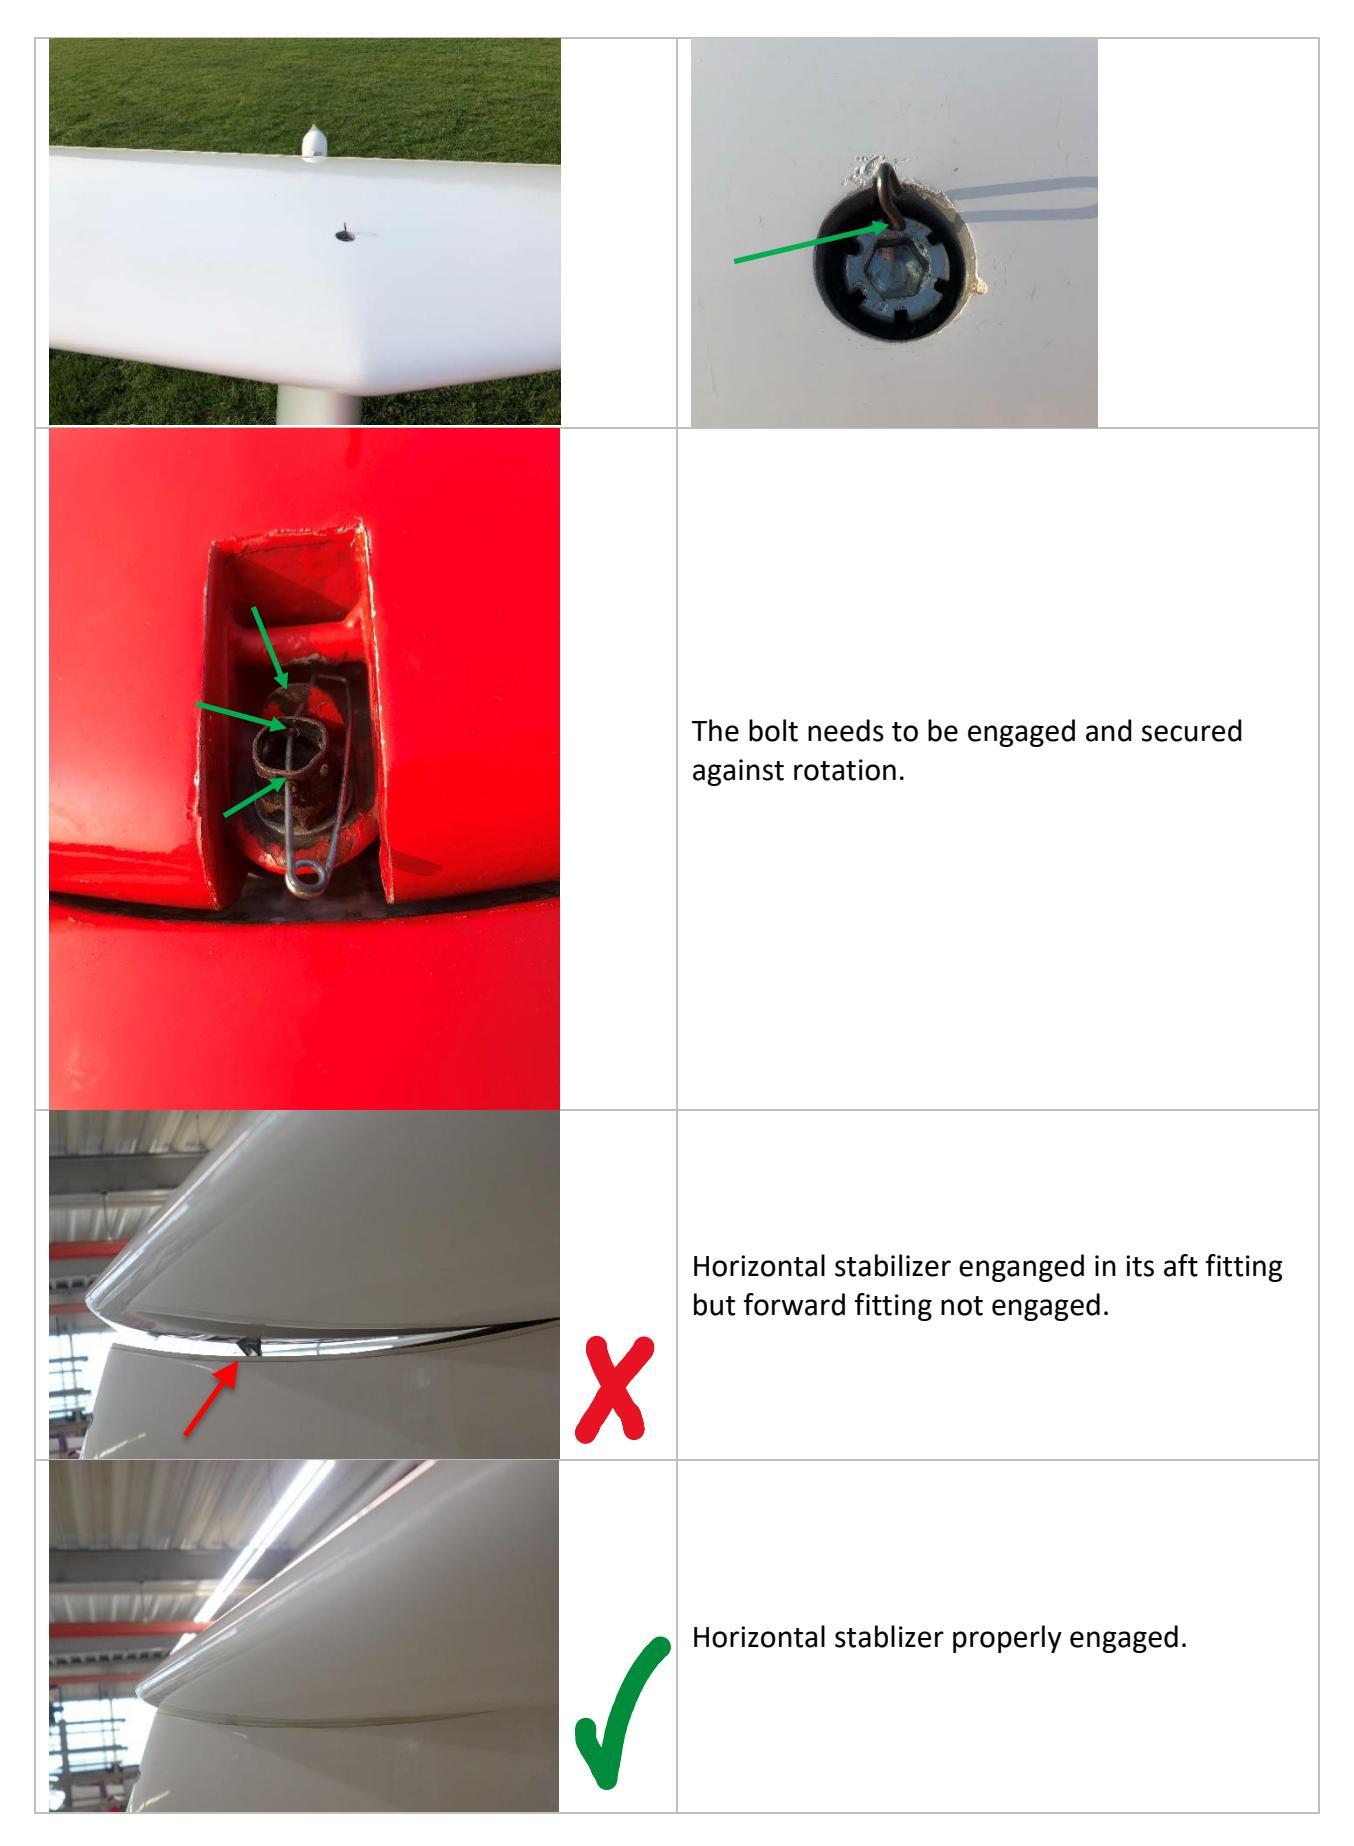
Engaged but <u>not</u> secured.	The bolt moved away from its engaged position, and the control is unconnected.
	The Fokker-needle needs to be pushed through both holes of the cage and the hole of the bolt.
Engaged and secured.

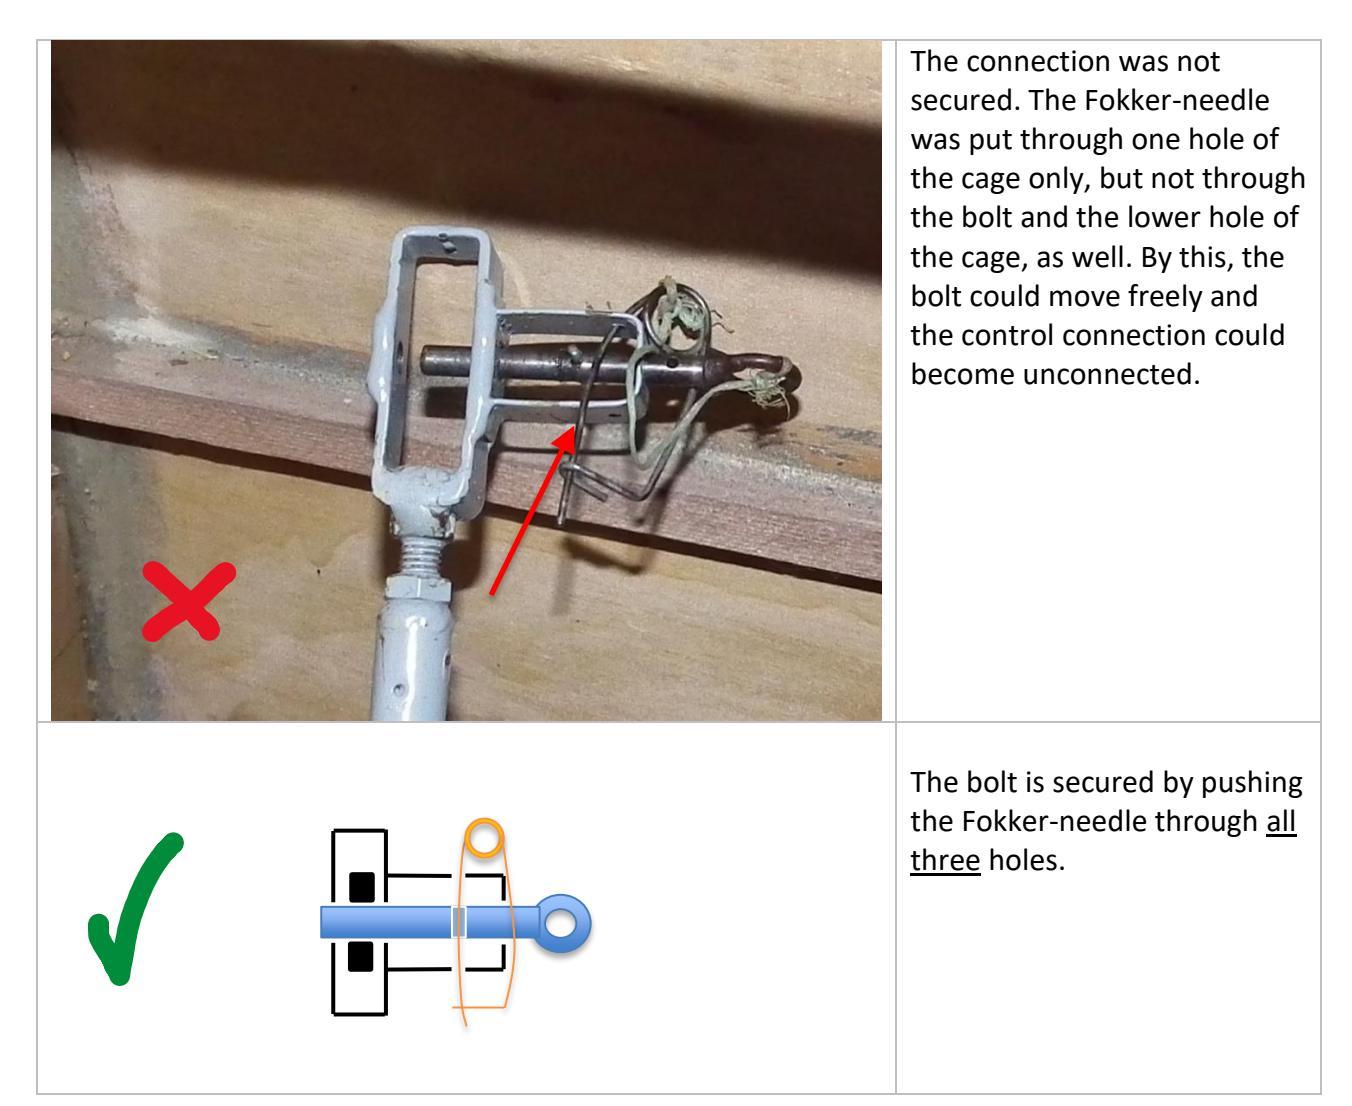
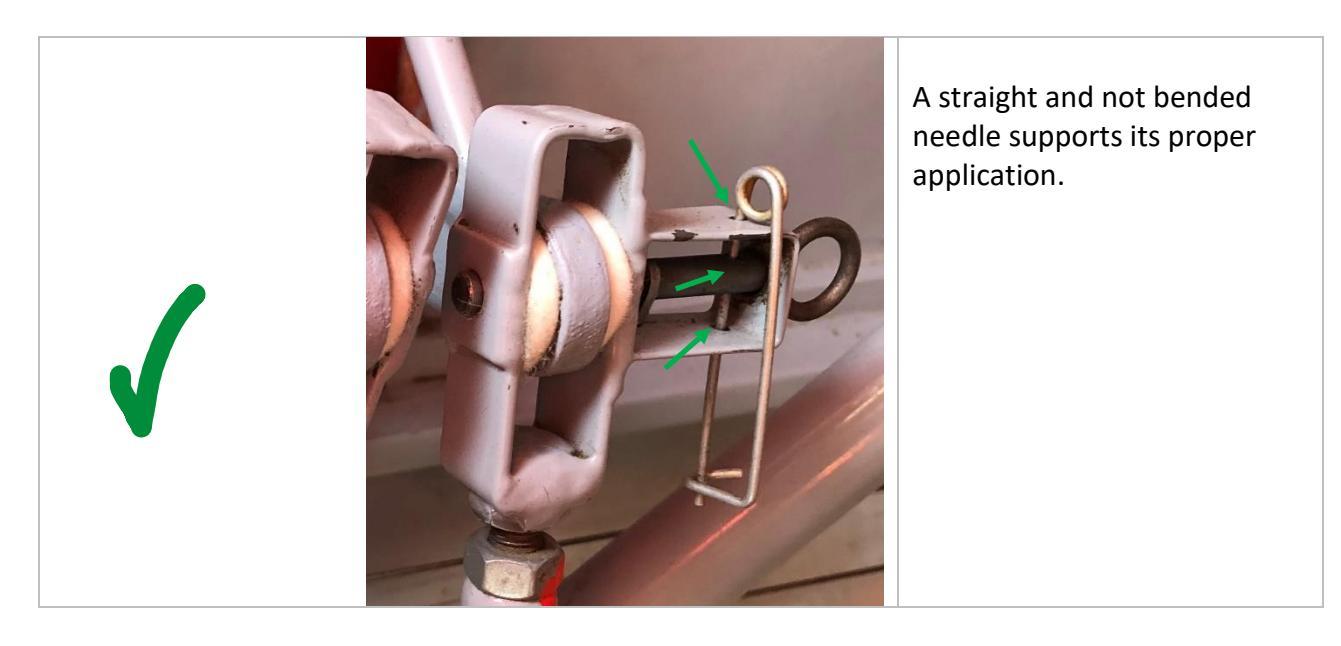
The example below shows an aileron connection, which is typical for old sailplanes with manual control connections. In this case, the connection was engaged during rigging, but not correctly secured. After three flights of short duration, the bolt moved away from its engaged position. The pilot lost control and crashed fatally.

Note: Connections, which are not properly secured, <u>cannot</u> be detected by positive control checks. The proper securing can be verified only by a manual inspection through turning, pulling, or shaking of the bolt and further visual inspection.

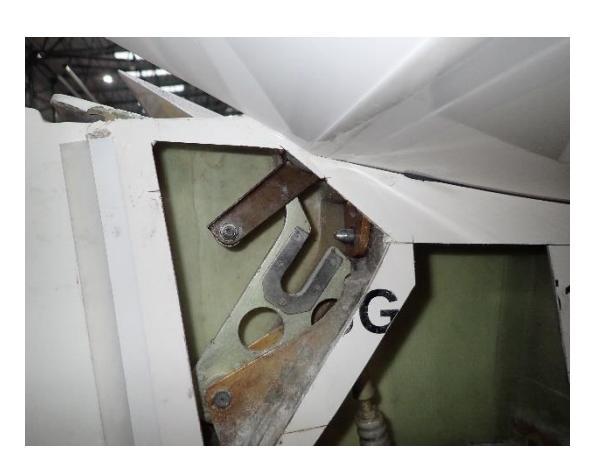
Similar designs can be found for the control connection of the elevator. Pictures below show an example of a mis-rigged vertical stabilizer, which led to a fatal accident. The mis-rigging had its root cause in an unauthorized and apparently unrecorded modification, to make rigging easier.

Disconnected elevator control

Note: Those examples of rigging errors can usually be detected by a proper positive control check as indicated above.

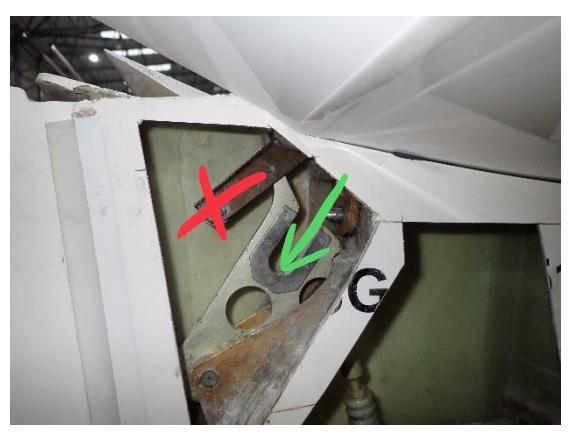
Disconnected elevator control

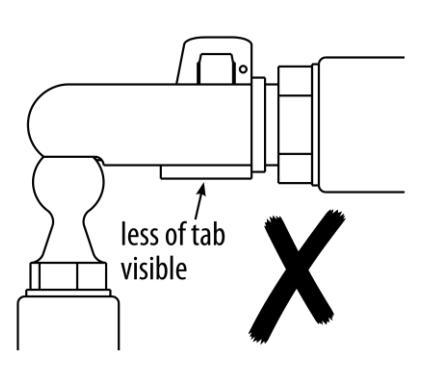
L'Hotellier connections rely upon proper engagement of a ball and socket, which are secured by a spring-loaded tab that must be pressed out of the way to make the connection. With the tab in position, a witness hole is exposed, allowing a locking pin/clip to be fitted to secure the connection. The controls can become disconnected in flight, if the pin is not fitted. Unfortunately, the tab adopts a similar position when the ball and socket are completely disconnected and, although the ball is then locked out of the socket, it may in some cases engage sufficiently for the controls to seem connected. Being able to insert the locking pin does not guarantee that the connection has been properly made.

(d) Incorrect: ball not engaged, but locking pin may still be inserted

It is crucial to check that the ball and socket are correctly engaged. This can be difficult, if access is tight or illumination poor; a torch and mirror, or telephone camera, can help.

*Note: To check the proper engagement of l'Hotellier connectors, a positive control check is strongly recommended.*

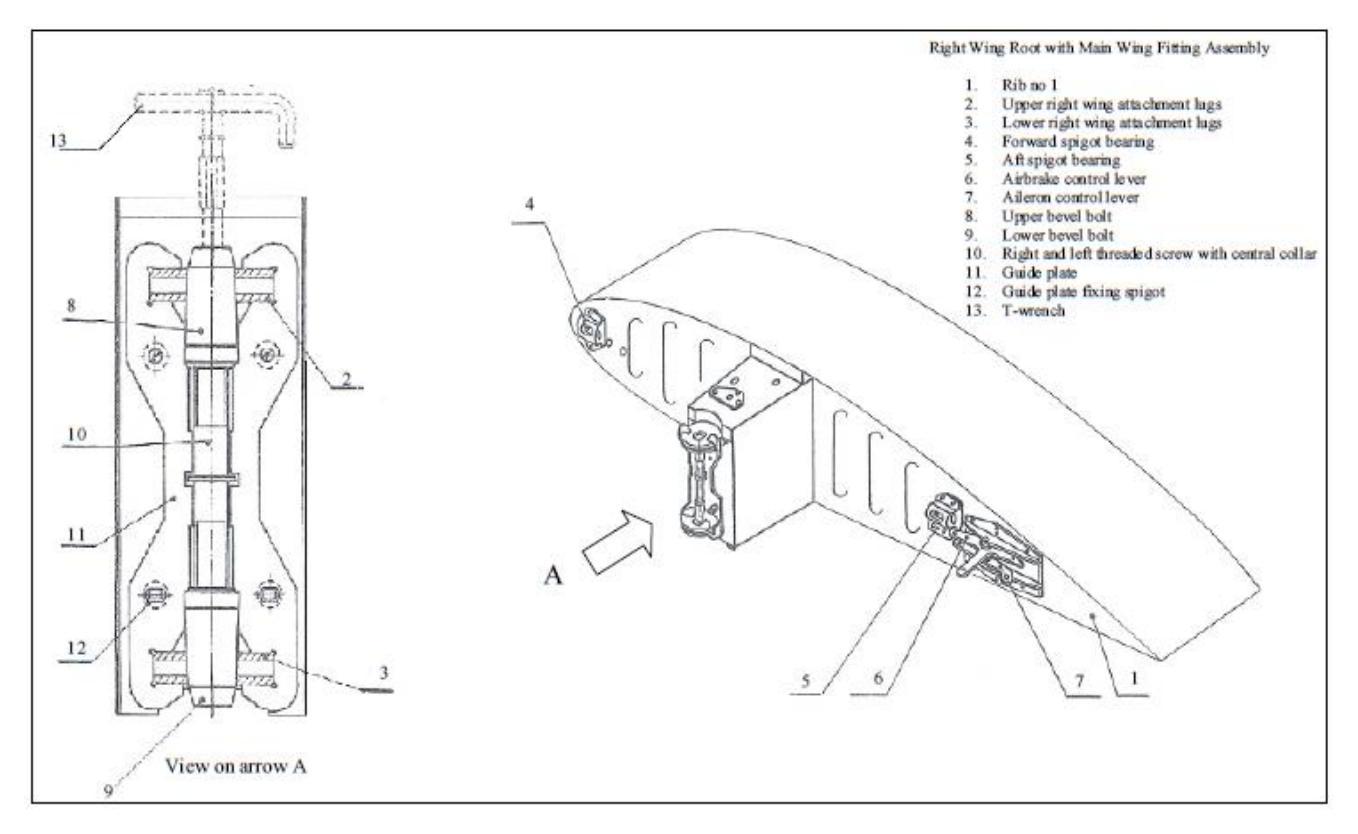
The wing rigging pins for most gliders are smooth cylinders, but those for e.g. the Foka, Cobra, Bocian, Jaskółka, Schempp-Hirth SHK and Austria, consist of expanding pins/cones, which must be fitted exactly in accordance with the instructions of the flight manual. If the pin/cone is not correctly located, the wings can fold up and detach from the fuselage. Unless inspection holes have been cut for the purpose, it can be very difficult in some gliders to see whether the fitting has been assembled correctly.

#### Example of an expanding main pin wing connection.

Note: In case of sailplanes with expanding main pin wing connections, practice rigging should be carried out under the supervision of someone who is familiar with the sailplane type.
